# Manhole Inspection Summary

Manhole # S1100\_015MH

Insp Date: **8/15/07 2:58 PM**

**Location** Address: **3113 HANLON AVE**

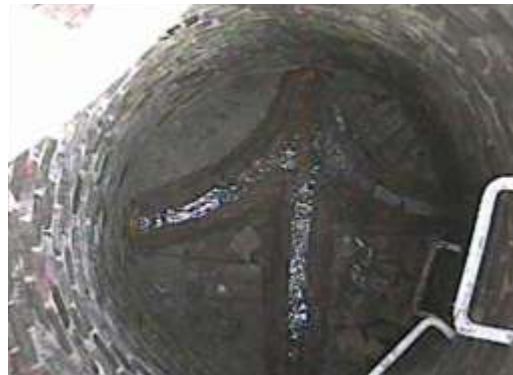
Defect 1

Condition: ☐ Sound ☐ Cracked ☐ Root Intrusion ☒ **Deteriorated** ☐ Leaks ☐ Debris

Count: **4** Missing: **0** ☒ **Corroded**

CORRODED STEPS , BENCH DEBRIS  
AND DETERIORATION

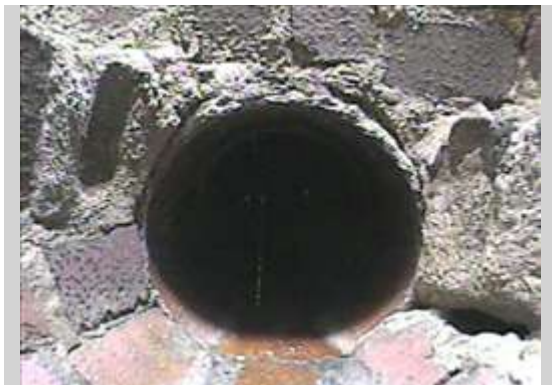
12 O'Clock Outflow

8 in. Circular Gravity Sewer  
Pipe Out @ 12 O'Clock

Pipe Material: **Clay** ☐ Pipe Lined

Invert Depth: **8.90** (ft.) Flow Characteristics: **Slow**

Deposits: ☒ None ☐ Mud ☐ Sludge ☐ Debris ☐ Grease

Infiltration: **None** Pipe Seal Cond: **Sound**

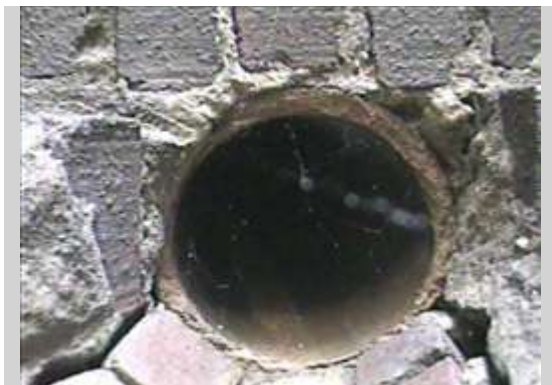
3 O'Clock Inflow

6 in. Circular Gravity Sewer  
Pipe In @ 3 O'Clock

Pipe Material: **Clay** ☐ Pipe Lined

Invert Depth: **8.76** (ft.) Flow Characteristics: **Slow**

Deposits: ☒ None ☐ Mud ☐ Sludge ☐ Debris ☐ Grease

Infiltration: **None** Pipe Seal Cond: **Sound**

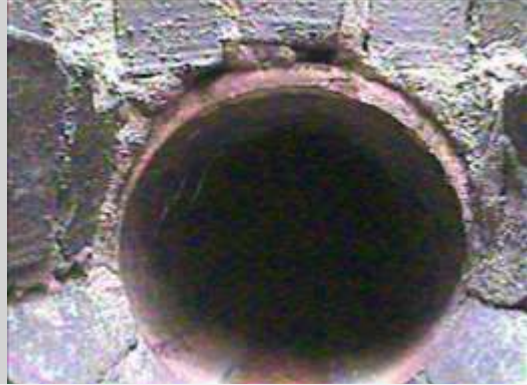
6 O'Clock Inflow

8 in. Circular Gravity Sewer

Pipe In @ 6 O'Clock

Pipe Material: **Clay** ☐ Pipe Lined

Invert Depth: **8.85** (ft.) Flow Characteristics: **Slow**

Deposits: ☒ None ☐ Mud ☐ Sludge ☐ Debris ☐ Grease

Infiltration: **None** Pipe Seal Cond: **Sound**

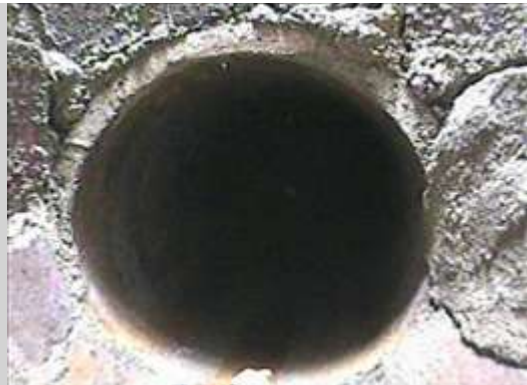
9 O'Clock Inflow

8 in. Circular Gravity Sewer

Pipe In @ 9 O'Clock

Pipe Material: **Clay** ☐ Pipe Lined

Invert Depth: **8.87** (ft.) Flow Characteristics: **Slow**

Deposits: ☒ None ☐ Mud ☐ Sludge ☐ Debris ☐ Grease

Infiltration: **None** Pipe Seal Cond: **Sound**
